Town of Red Springs, NC

Power Surge Event Investigation Report

April 1, 2026

Power Surge Event Investigation

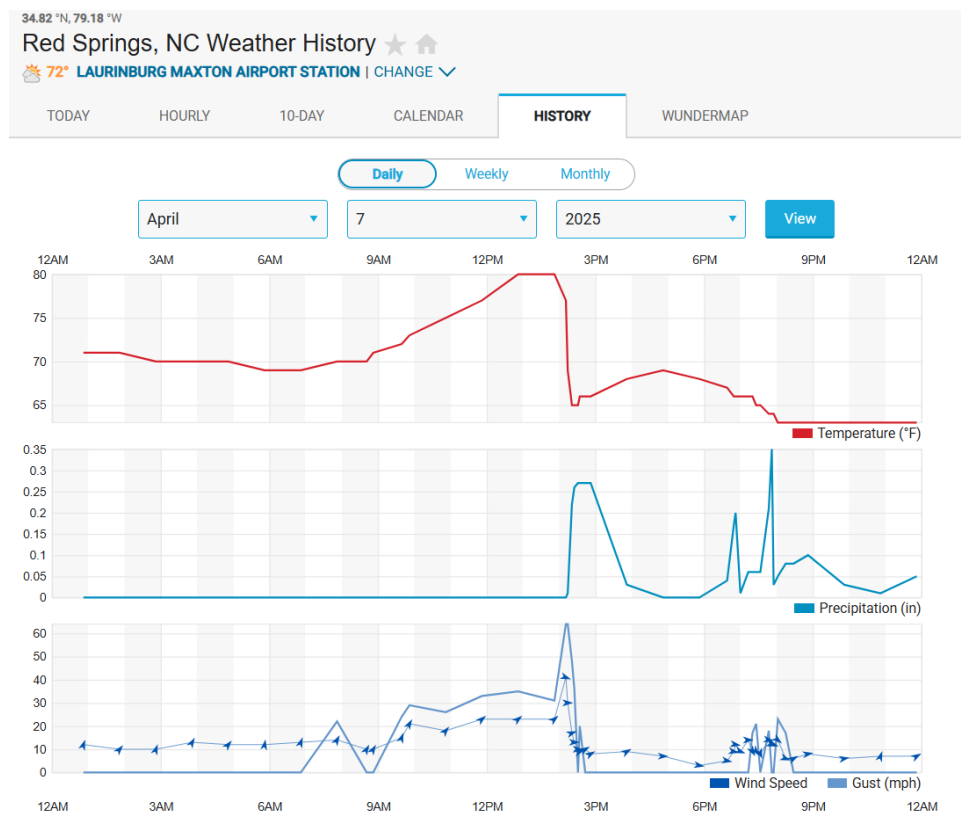
The consensus presented by Town staff when interviewed was that the power surge was caused by a 24.9 kV line contacting a 4.16 kV line where they cross in close proximity, and that this was due to a high wind event causing motion of the conductors (RGrid Power confirmed the wind event with local weather history data. See Photo 1).

Photo 1: April 7, 2025 Weather History – WeatherUnderground.com

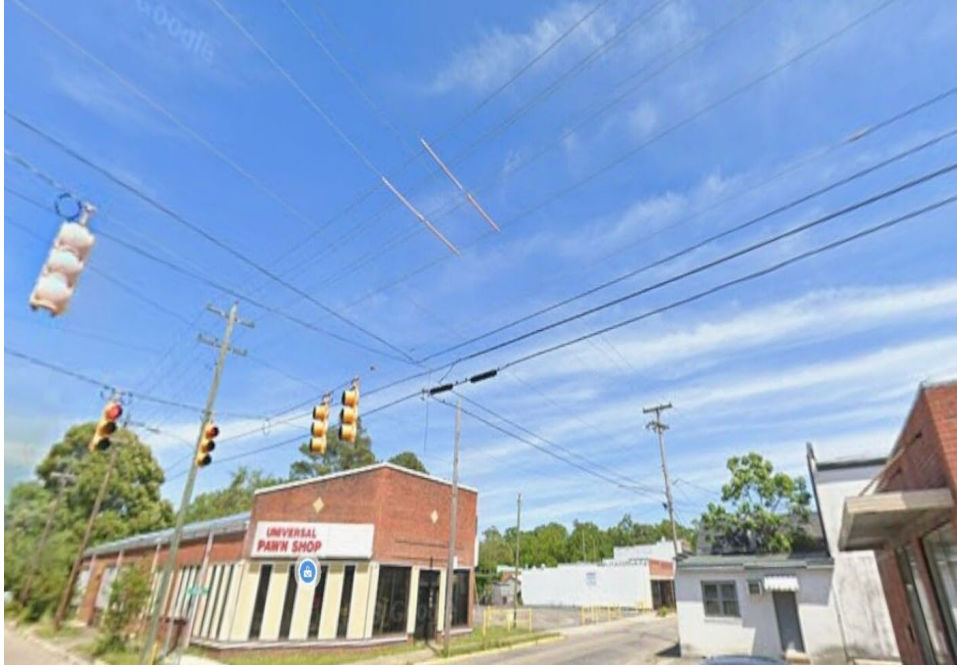
The Town staff advised that immediate post-event action was taken by increasing the spacing between these feeders. This is apparent from a comparison of the pole just outside

the Universal Pawn Shop between Photo 2 and Photo 3 below. Although this does decrease the probability of a repeat occurrence of a contact event, it may not eliminate the possibility that it could happen again given an extreme weather event.

Photo 2: Line crossing prior to additional line spacing

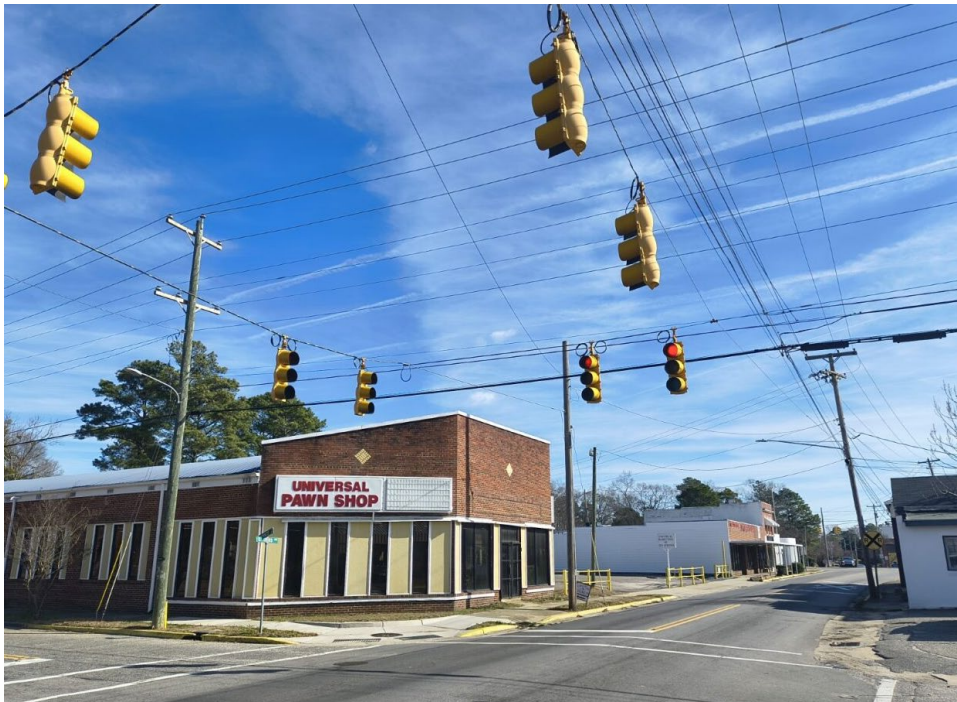
Photo 3: Increased feeder spacing

The Town staff's diagnosis of the problem and corrective action immediately following the April 2025 surge event appears to have been appropriate. RGrid Power recommends additional measures to further improve system reliability and operations.

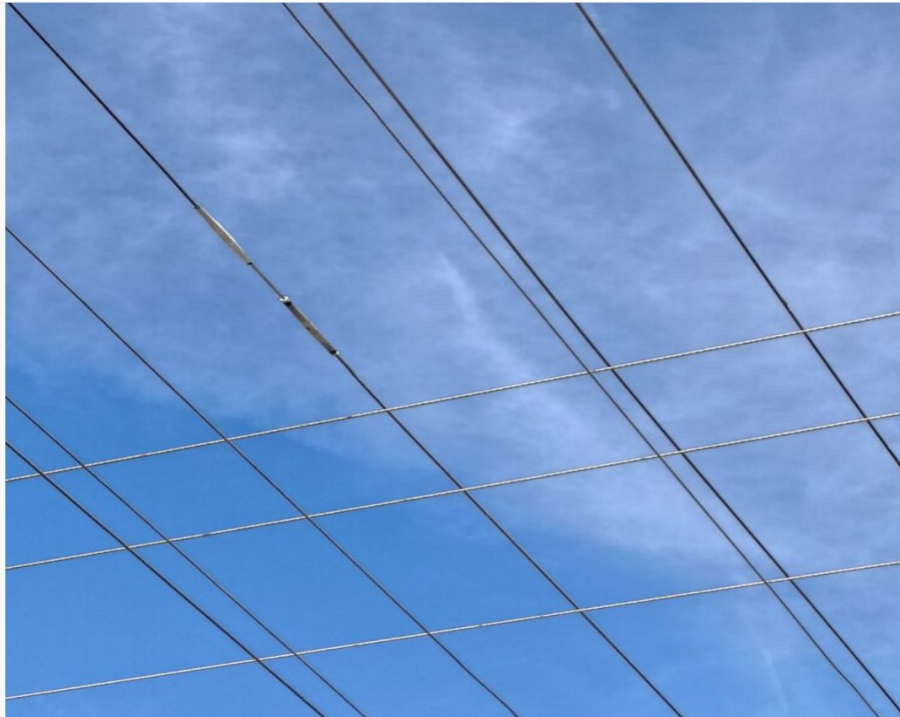
It also appears that the April 7, 2025, voltage surge may not have been the only time that the feeders have made contact. Photo 4 (below) shows two different conductor splices that could correspond to other past contact event(s). The fact that the splices are different, and are in slightly different points in the feeder with sections of normal conductor between them is an indication that this may have happened at separate times.

Photo 4: Conductor splices

- 5.) **Voltage conversion**- The proposed voltage conversion for the remaining 4.16 kV portions of the distribution system is recommended. In addition to the loss savings and other benefits that the Town would see from voltage conversion, if the Town feeders were all upgraded to 24.9/14.4 kV, an unintentional contact event between different circuits or phase conductors could still result in an outage. However, during the voltage conversion design process, potential conflict areas can be eliminated, especially with the removal of additional 4.16 kV circuits, which would free up valuable space on the Town’s poles as well as replacing some of the oldest equipment on the system. The likelihood of events like the April 2025 event will be greatly reduced. Together with the other recommended measures in this report, the Town will improve overall reliability and reduce the likelihood of future similar outages.

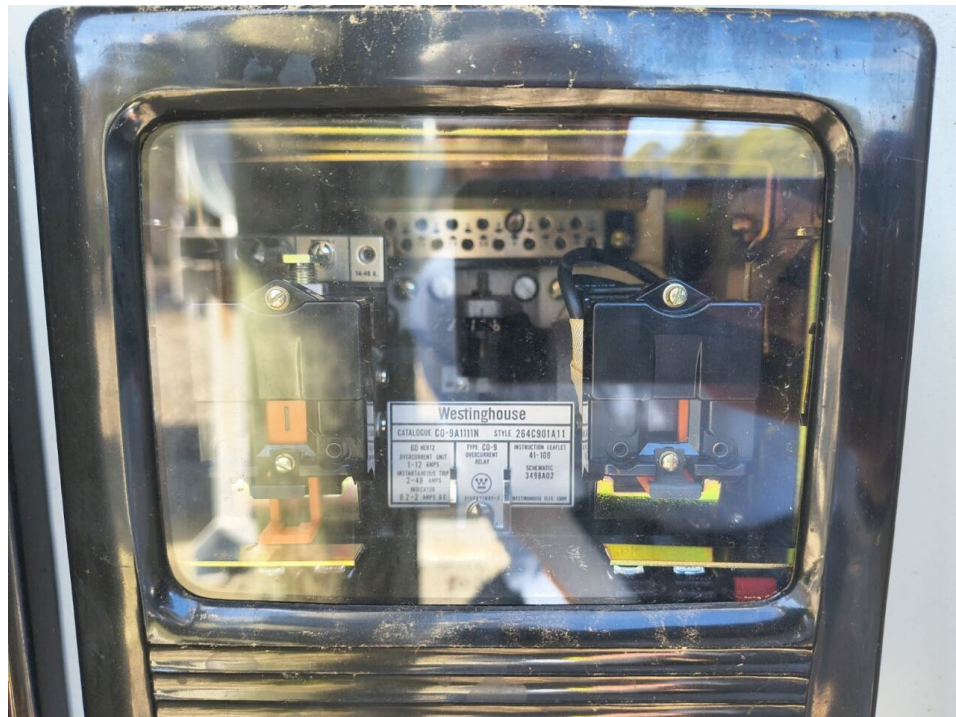
- 1.) **Test relays in the Highway 71 Substation-** Town staff indicated that the Duke Energy breaker operated during the surge event, while the Town of Red Springs feeder protection device did not. It is possible that the Duke Energy electronic relay operated faster than the Town's electromechanical relay, but we also observed that the Town's relay had not been tested since 2005. Although the Town's system is well below the NERC Bulk Electric System threshold for required 5-year testing, a 5-year testing cycle is generally accepted as 'good utility practice' making sure that relays are in working condition and drive the protective device to operate during fault conditions. Electromechanical relays are generally reliable, but sometimes the springs or other mechanical components become weaker with age and stop working within specified tolerances or require adjustment to perform as specified. RGrid Power recommends that the Town establish and fund a regular testing program, which can be done for a reasonable annual cost. Regular testing often identifies and corrects problems before they cause unnecessary or prolonged outages. Replacement of older protective relays or equipment can also result in faster and better coordinated clearing of fault events on the electric system which may reduce or prevent damage to equipment when these abnormal conditions occur.

Photo 5: Electromechanical relay at Highway 71 Substation

- 2.) **Review relay settings**-A possibility for the Duke Energy operation ahead of the Town's device may be due to an issue with relay coordination. The settings in the Town's electromechanical relays were obtained by visual observation and the settings for the Duke Energy recloser were provided by Electricities. Initial review shows the Duke recloser's ground curves operating before the Red Springs relay for faults under 4,000 amps (TCC Plot and Duke settings attached). A system sectionalizing and coordination study is recommended, which will identify any potential coordination problems throughout the system which can then be corrected. This will likely result in fewer and shorter outages over time (i.e. Better overall reliability).
